# Manhole Inspection Summary

Manhole # S47KK\_026MH

Insp Date: **5/2/08 12:20 PM**

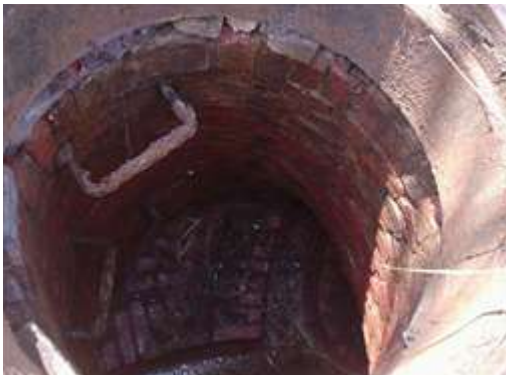
Defect 2

Infiltration: ☐ None ☒ **Joint** ☐ Cracks ☐ Mortar ☐ Roots ☐ Wall

Infiltration

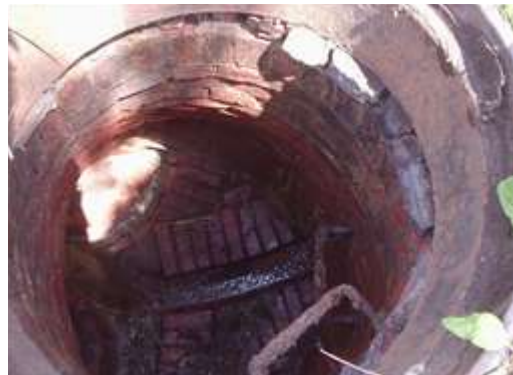
Defect 1

Condition: ☐ Sound ☐ Cracked ☐ Root Intrusion ☒ **Loose Brick** ☐ Deteriorated

Loose Bricks

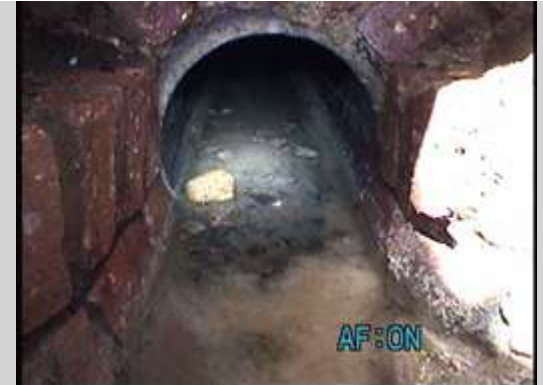
12 O'Clock Outflow

8 in. Circular Gravity Sewer  
Pipe Out @ 12 O'Clock

Pipe Height: **8.4** (in.) Rod and Bar (Angled)  
Pipe Material: **Clay** ☐ Pipe Lined  
Invert Depth: **7.20** (ft.) Flow Characteristics: **Slow**  
Deposits: ☒ None ☐ Mud ☐ Sludge ☐ Debris ☐ Grease  
Silt Depth: (in.) Deposits Extent:  
Infiltration: **None** Pipe Seal Cond: **Sound**

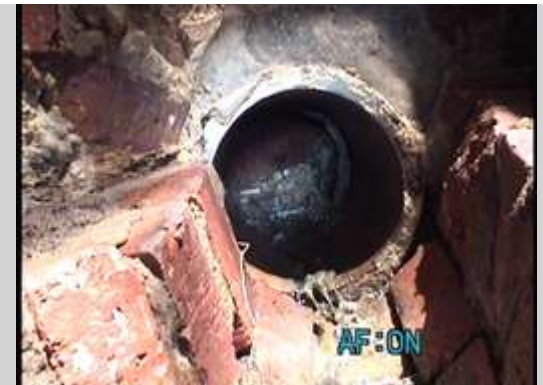
3 O'Clock Inflow

6 in. Circular Gravity Sewer  
Pipe In @ 3 O'Clock

Pipe Height: **6** (in.) Rod and Bar (Angled)  
Pipe Material: **Clay** ☐ Pipe Lined  
Invert Depth: **6.40** (ft.) Flow Characteristics: **Slow**  
Deposits: ☒ None ☐ Mud ☐ Sludge ☐ Debris ☐ Grease  
Silt Depth: (in.) Deposits Extent:  
Infiltration: **None** Pipe Seal Cond: **Sound**

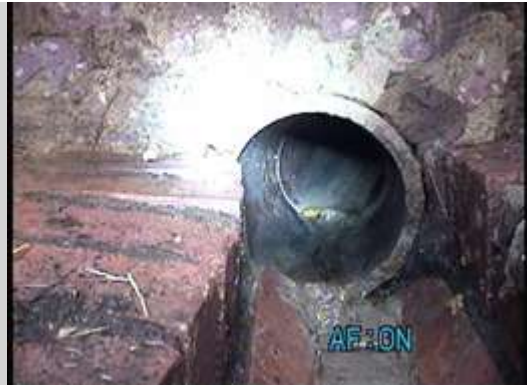
5 O'Clock Inflow

6 in. Circular Gravity Sewer

Pipe In @ 5 O'Clock

Infiltration: **None**

Pipe Seal Cond: **Sound**

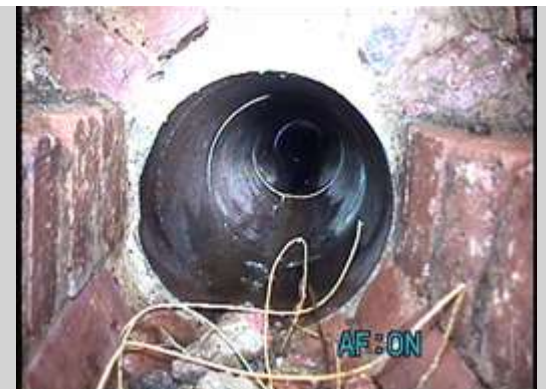
9 O'Clock Inflow

8 in. Circular Gravity Sewer

Pipe In @ 9 O'Clock

Infiltration: **None**

Pipe Seal Cond: **Sound**
